# Infrared Inspection of Masonry

By Carrie J. Johnson, P.E. and Thomas W. Wallace, P.E.

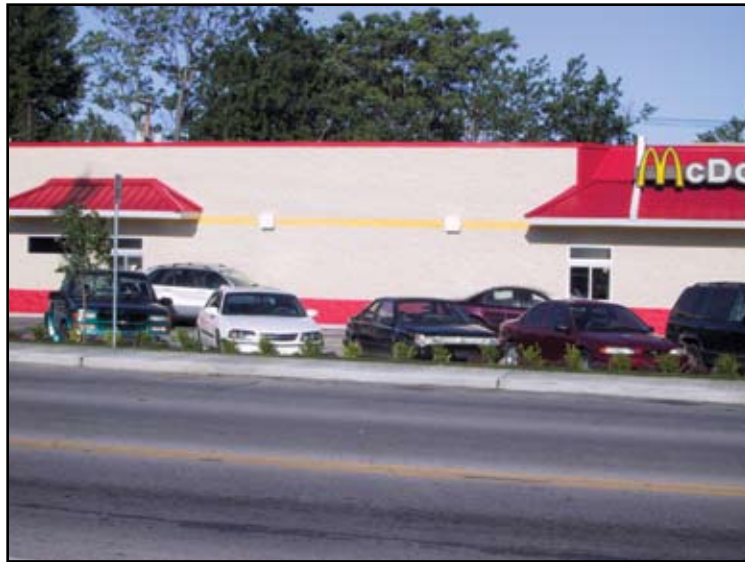
Figure 1: Exterior View of a CMU Wall Taken with a Digital Camera

Images taken with an infrared camera show a distinct difference between the grouted cells and ungrouted cells, creating a clear indication of which cells are grouted. *Figure 1* shows a picture of a CMU wall taken with a standard digital camera during the day. *Figure 2* shows a picture of the same wall taken with an infrared camera at night. The lighter areas in *Figure 2* indicate cells that contain grout. The darker areas are either ungrouted or contain insulation. Most infrared cameras can take images in either color or black and white. Using black and white pictures shows a more distinct difference between grouted and ungrouted areas. Areas where the lighter vertical portions of the wall are discontinuous indicate inadequate grouting of the cells.

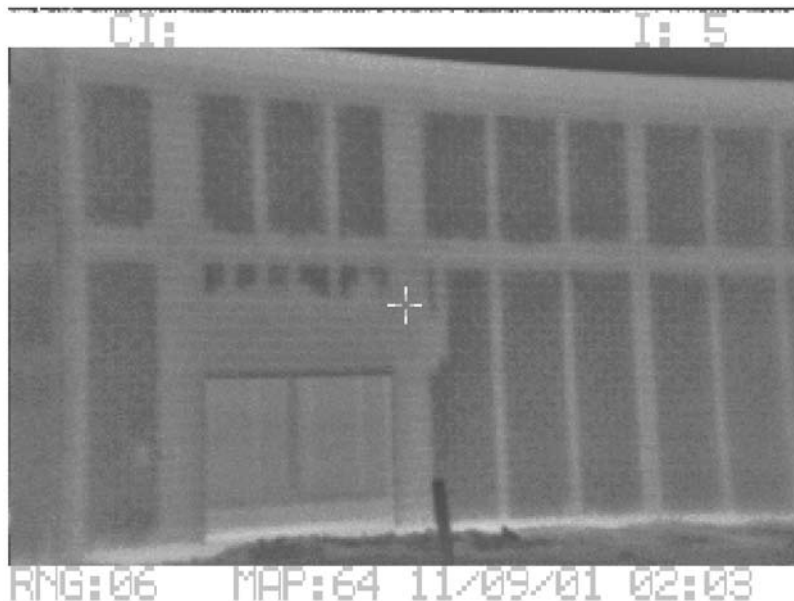
Figure 3: Infrared Picture of a Properly Grouted CMU Wall

Figures 3 and 4 show examples of infrared inspections of CMU walls of similar size. In Figure 3, regular spacing of vertically grouted cells within the wall are present and the correct spacing can be confirmed. Horizontal

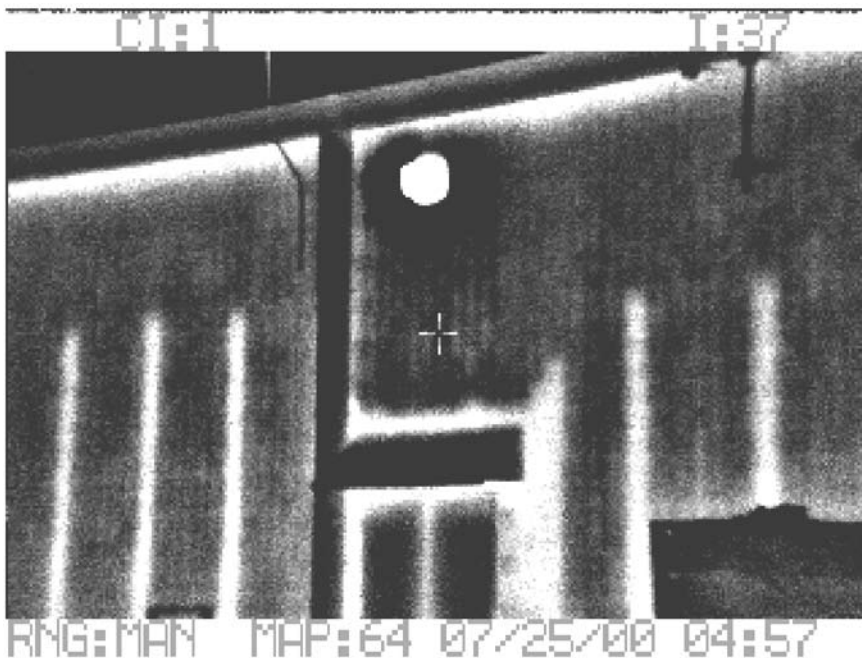
Figure 4: Infrared Picture of a CMU Wall with Discontinuities in the Grout

bond beams at the top of the wall and near the center of the wall can be verified. Grouting in the lintel and jambs can be confirmed around the openings. In *Figure 4*, discontinuities in the vertical reinforcing are indicated. The grouted cells around the opening are discontinuous, and the spacing of the vertical cells is not consistent. For repair drawings, the oval indicators shown in *Figure 4* are used to highlight areas that require repair, a key plan and list of the areas requiring repairs is issued, and repair details are provided. An example repair detail is shown in *Figure 5*. The detail includes information on the appropriate steps required to remove face shells, place missing grout and reinforcing, and replace face shells.
